**Flood Control Project Maintenance
Levee Inspections**
LMA District Cover Sheet
Spring 2018 Levee Inspection Results

Reclamation District No. 2107 Mossdale Island

Levee Inspection Report By Mile - Spring 2018

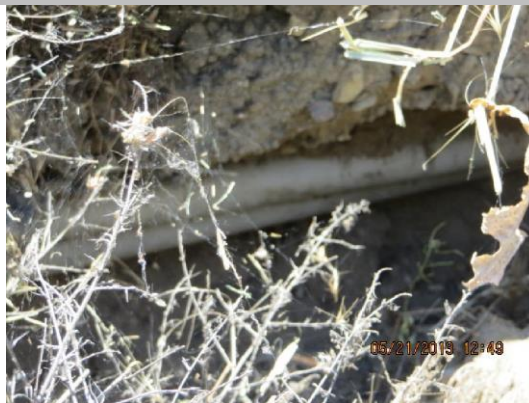
Photo 2 of 2 : UCIP_SP_2018_15173_24917.jpg

Pipes visible on LS next to roadway.

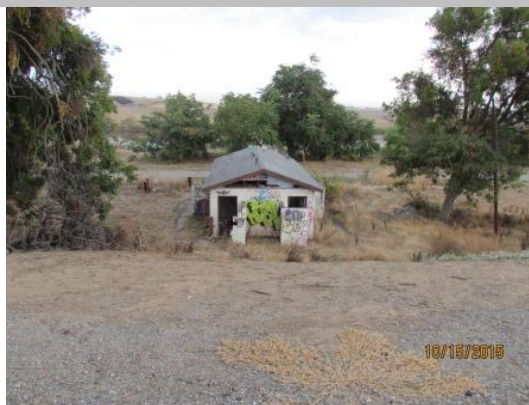
Photo 1 of 1 : SP_2018_RD2107_329_20_20180305_00005.jpg

LM Start	0.32	Rating **	M	Issue No.	20
LM End	0.32	Issue Type +	En	Location *	WS
Category	Earthen Levee			GPS Latitude/Longitude	
				Start	End
Item	Encroachments			37.783649 °	37.783649 °
				-121.305710 °	-121.305710 °
DWR ID	DWR_RD2107_01_f_2015_20				
Comment Code					
BU : Building					
Inspector Comment					
Building in the floodway may impede flood flows.

View of the building in the floodway.

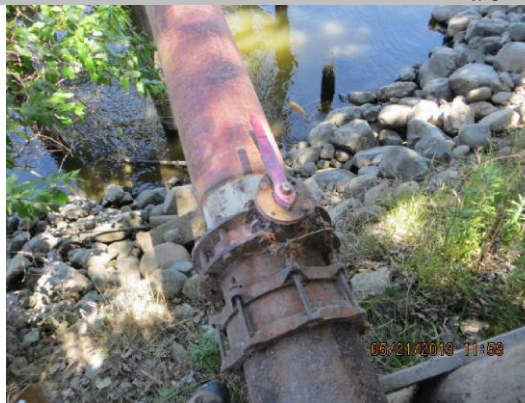
Photo 3 of 3 : UCIP_SP_2018_13684_22409.jpg

Butterfly valve on WS toe.

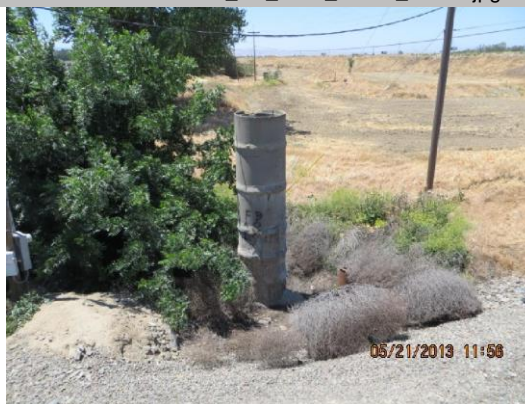
Photo 1 of 2 : UCIP_SP_2018_13883_22821.jpg

Comment Code					
Inspector Comment					
FS_ID:13883					
DS_ID:19039					
EP_NO: N/A					
Repair Type: Non-Urgent					
Crossing Status: Found					
UCIP Comments: Slide gate missing actuator inside 55-inch CMP riser.					
FIELD_STRUCT_DESC: 14-inch irrigation pipe of an unknown material					
through the levee, 15 feet below the crown. Pipe likely runs from a 36-					
inch concrete standpipe on the landside (LS) to outlet on the waterside					
(WS) toe. Portion of the discharge line from the pump at Levee Mile

36-inch concrete standpipe on LS toe.

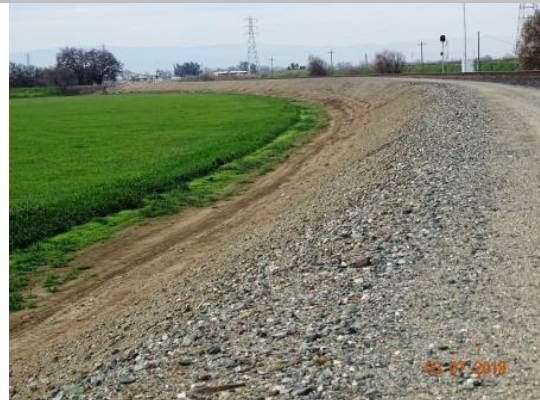
Photo 1 of 1 : SP_2018_RD2107_329_14_20180307_00024.jpg

LM Start	0.78	Rating **	A	Issue No.	14
LM End	0.78	Issue Type +	Ma	Location *	WS
Category	Earthen Levee			GPS Latitude/Longitude	
				Start	End
Item	Vegetation			37.778668 °	37.778668 °
				-121.303248 °	-121.303248 °
DWR ID	DWR_RD2107_01_s_2018_14				
Comment Code					
V1 : Control annual grass and weeds on the levee slopes and easements.					
Inspector Comment					
Acceptable vegetation control.

View of the acceptable vegetation control on the waterside levee slope, looking upstream.

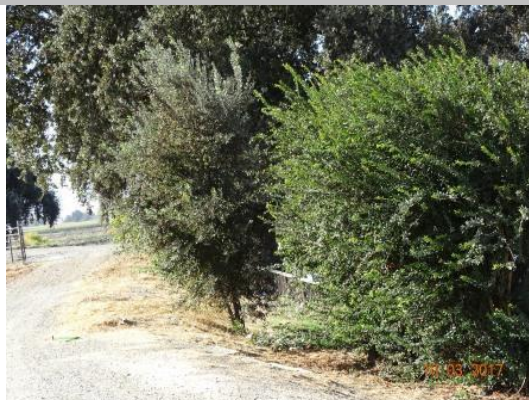
Photo 1 of 1 : SP_2018_RD2107_329_17_20180305_00004.jpg

LM Start	1.23	Rating **	M	Issue No.	17
LM End	1.23	Issue Type +	En	Location *	LS
Category	Earthen Levee			GPS Latitude/Longitude	
				Start	End
Item	Vegetation			37.774123 °	37.774123 °
				-121.307189 °	-121.307189 °
DWR ID	DWR_RD2107_01_s_2012_17				
Comment Code					
V6 : Landscaping					
Inspector Comment					
Landscaping and fence present on levee slope.

View of landscape planting on landside levee slope and a 3-ft yard fence at the levee toe.

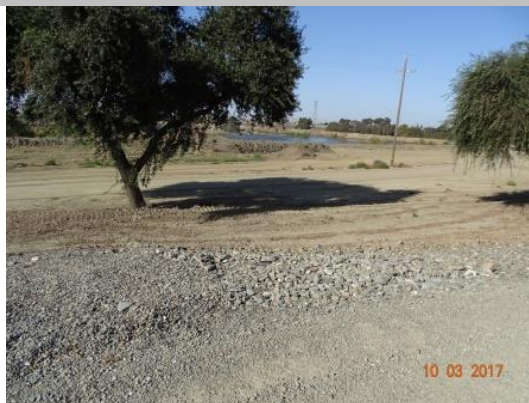
Photo 1 of 1 : SP_2018_RD2107_329_15_20180305_00003.jpg

LM Start	1.34	Rating **	A/W	Issue No.	15
LM End	1.34	Issue Type +	Ob	Location *	
Category	Supplemental			GPS Latitude/Longitude	
				Start	End
Item	2017 Storm Damage			37.772704 °	37.772704 °
				-121.306793 °	-121.306793 °
DWR ID	DWR_RD2107_01_f_2017_15				
Comment Code					
Inspector Comment					
Levee Evaluation Comments					
Description:					
Site ID No:111					
Site Designation:208-4					
Repair Type: Seepage					
Rating:					
Field Date:					
Notes: In 1997 there was heavy seepage at this location. In 2017 there was no seepage observed at this location.

View of the historic seepage site.

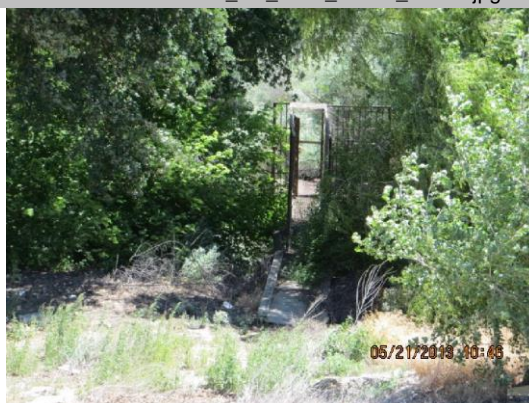
Photo 1 of 3 : UCIP_SP_2018_13650_22341.jpg

LM Start	1.47	Rating **	M	Issue No.	29
LM End	1.47	Issue Type +	En	Location *	
Category	Supplemental			GPS Latitude/Longitude	
				Start	End
Item	DWR UCIP Field Study			37.771735 °	37.771735 °
				-121.304847 °	-121.304847 °
DWR ID					
Comment Code					
Inspector Comment					
FS_ID:13650 DS_ID:19040 EP_NO: N/A Repair Type: Non-Urgent Crossing Status: Found UCIP Comments: No pump. Appears abandoned. Large hole under pipe on WS slope from animal activity. FIELD_STRUCT_DESC: 1 of 2: 18-inch polyvinyl chloride (PVC) irrigation pipe through the levee, 2.5 feet below the crown. Pump on pile structure in the stream. Walkway to the pump. [Additional Reference(s): DWR Levee Log, 2005. USACE San Joaquin O&M Manual 9, April 1964, (HLM 1.49)]. FS Date: 5/21/2013

Pumping plant on metal pier on WS toe.

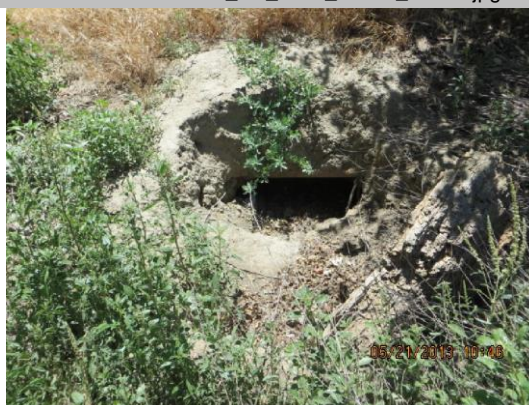
Photo 2 of 3 : UCIP_SP_2018_13650_22340.jpg

Large hole under pipe on WS slope.

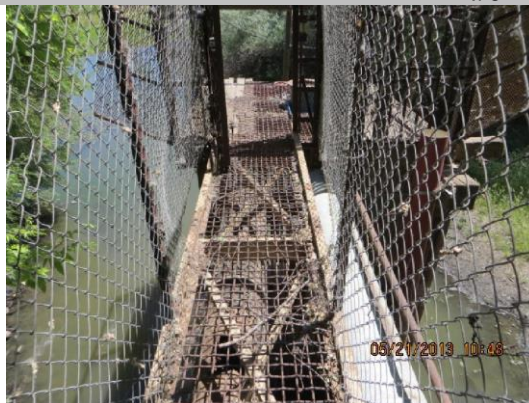
Photo 3 of 3 : UCIP_SP_2018_13650_22339.jpg

Pumping plant on metal pier on WS toe. Pipe visible on right under walkway.

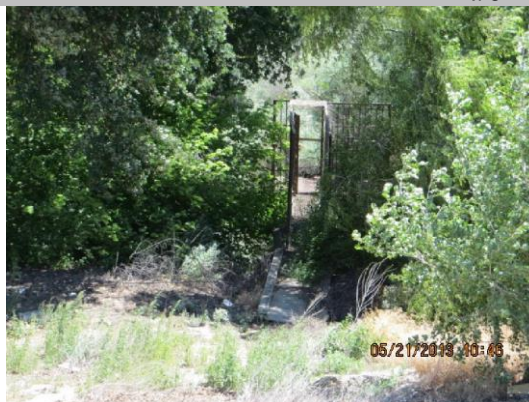
Photo 1 of 3 : UCIP_SP_2018_15179_24935.jpg

LM Start	1.47	Rating **	M	Issue No.	30	
LM End	1.47	Issue Type +	En	Location *		
Category	Supplemental			GPS Latitude/Longitude		
				Start	End	
Item	DWR UCIP Field Study			37.771735 °	37.771735 °	
				-121.304847 °	-121.304847 °	
DWR ID						
Comment Code						
Inspector Comment						
FS_ID:15179						
DS_ID:23106						
EP_NO: N/A						
Repair Type: Non-Urgent						
Crossing Status: Found						
UCIP Comments: Pipe open on WS toe at the pump on pier. Pipe abandoned and should be done so properly.						
FIELD_STRUCT_DESC: 16-inch steel irrigation pipe through the levee, 2.5 feet below the crown. Pump on pile structure in the stream.						
Walkway to the pump.						
FS Date: 5/21/2013

Metal pier on WS slope.

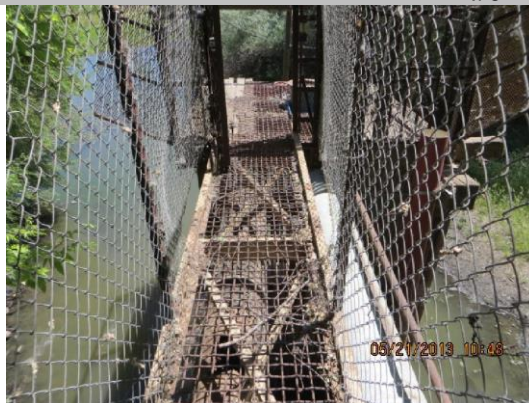
Photo 2 of 3 : UCIP_SP_2018_15179_24934.jpg

Pipe visible under metal walkway on WS slope.

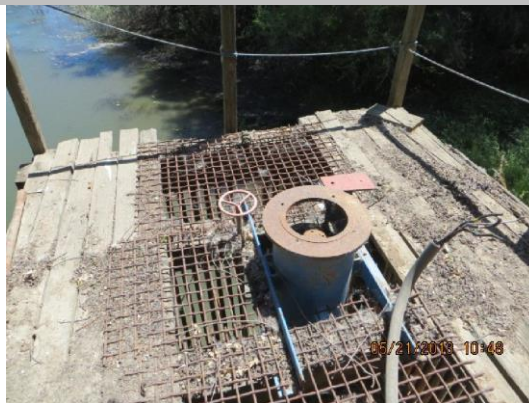
Photo 3 of 3 : UCIP_SP_2018_15179_24933.jpg

Pipe open at pump on platform on WS.

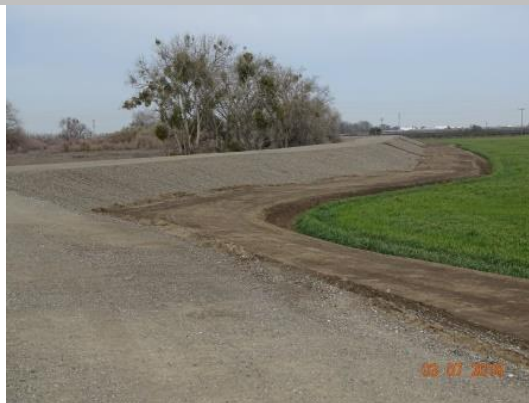
Photo 1 of 1 : SP_2018_RD2107_330_5_20180307_00010.jpg

View of the acceptable vegetation control on the levee slope, looking downstream.

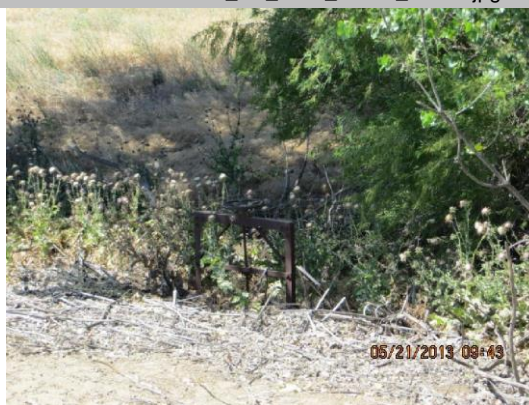
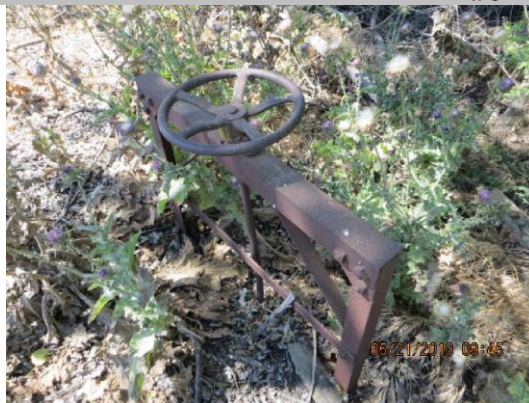
LM Start	0.27	Rating **	M	Issue No.	6
LM End	0.27	Issue Type +	Ma	Location *	
Category	Supplemental			GPS Latitude/Longitude	
				Start	End
Item	DWR UCIP LMA Responsibility			37.762613 °	37.762613 °
				-121.313480 °	-121.313480 °
DWR ID					
Comment Code					
Inspector Comment					
FS_ID:13637					
DS_ID:19057					
EP_NO: N/A					
Repair Type: Non-Urgent					
Crossing Status: Found					
UCIP Comments: Pipe filled in with soil around outlet and not visible on LS. Appears abandoned and should be done so properly.					
FIELD_STRUCT_DESC: *ABANDONED* 16-inch steel drainage pipe, 16 feet below the crown. Slide gate on the waterside (WS) toe.					
[Additional Reference(s): DWR Levee Log, 2005. USACE San Joaquin O&M Manual 9, April 1964, (HLM 0.27)].					
FS Date: 5/21/2013

Slide gate visible on WS toe.

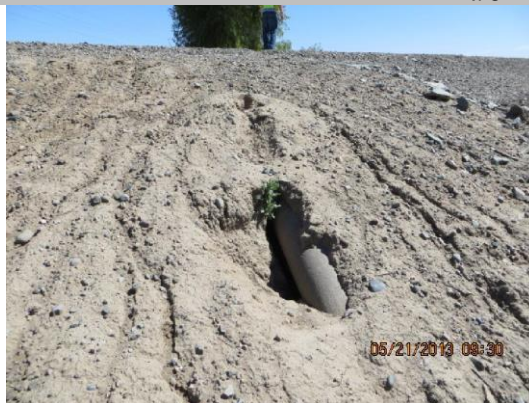
Photo 1 of 3 : UCIP_SP_2018_13636_22296.jpg

LM Start	0.54	Rating **	M	Issue No.	7
LM End	0.54	Issue Type +	En	Location *	
Category	Supplemental			GPS Latitude/Longitude	
				Start	End
Item	DWR UCIP Field Study			37.764832 °	37.764832 °
				-121.317405 °	-121.317405 °
DWR ID					
Comment Code					
Inspector Comment					
FS_ID:13636 DS_ID:19058 EP_NO: 13161 Repair Type: Non-Urgent Crossing Status: Found UCIP Comments: Some erosion along pipe alignment on WS slope. FIELD_STRUCT_DESC: 10-inch steel drainage pipe through the levee, 5 feet below the crown. Pump located on a 36-inch concrete standpipe at the landside (LS) toe. A polyvinyl chloride (PVC) pipe runs parallel to the waterside (WS) toe to the train tracks. Air relief valve on the WS shoulder. (Permit No. 13161, 1981 - [owner not indicated in permit database]). [Additional Reference(s): DWR Levee Log, 2005]. FS Date: 5/21/2013

Erosion along pipe alignment on WS slope.

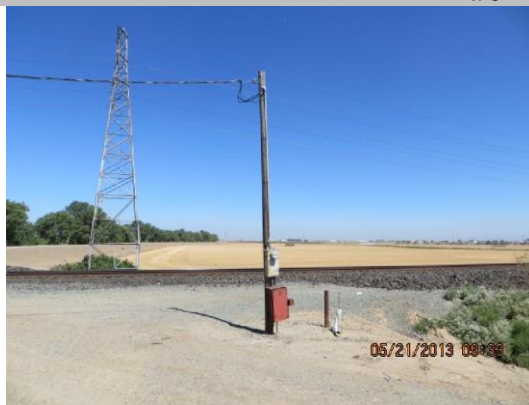
Photo 3 of 3 : UCIP_SP_2018_13636_22294.jpg

JP and meter on LS shoulder.

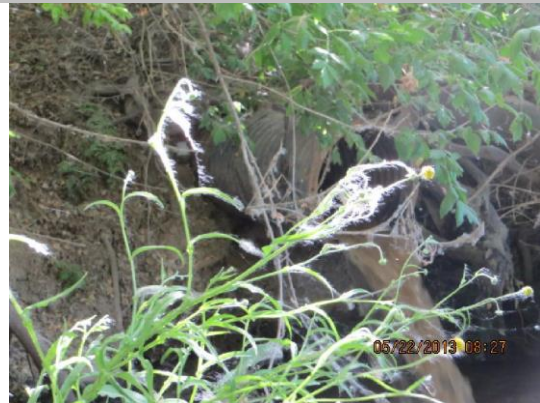
Photo 1 of 3 : UCIP_SP_2018_52565_22441.jpg

Comment Code						
Inspector Comment						
FS_ID:52565 DS_ID:19056 EP_NO: 2966 Repair Type: Urgent Crossing Status: Found UCIP Comments: 11/29/2017 Received update from DWR levee inspector M. Khashchuk and pipe is visible on WS toe with flap gate open: back filled during high winter flow to prevent erosion (no photos are available of back fill work). No updates were provided regarding repairs to the sink hole located on LS toe or internal inspection of pipe through the levee, pipe crossing remains urgent. (DWR UCIP - O. Magana)11/16/2016 Visible hole through pipe visible on WS end. Sink hole present at the LS ditch. Evidence of pipe repair visible on LS (see photos) however, no permit was found to document the work. Need to contact owner to determine permit authorizing work. Due to the hole in the pipe recommend internal inspection of the pipe through the levee to determine pipe integrity. (O. Magana - DWR UCIP)05/22/2013 Headwall around pipe at LS toe is failing and should be shored up. Flap gate propped open and should be returned to normal function. (W. Wylie - DWR UCIP) FIELD_STRUCT_DESC: 24-inch steel drainage pipe through the levee, 14 feet below the crown. Flap gate on the waterside (WS) end of the pipe. Two standard reinforced concrete cutoff walls around the pipe in line with the levee shoulders. (Permit No. 2966, 1958 - Dell'Oso Brothers). FS Date: 11/17/2016 10:50:00 AM

Pipe visible on WS toe with Flap gate open.

FS_ID:52565
DS_ID:19056
EP_NO: 2966
Repair Type: Urgent
Crossing Status: Found
UCIP Comments: 11/29/2017 Received update from DWR levee inspector M. Khashchuk and pipe is visible on WS toe with flap gate open: back filled during high winter flow to prevent erosion (no photos are available of back fill work). No updates were provided regarding repairs to the sink hole located on LS toe or internal inspection of pipe through the levee, pipe crossing remains urgent. (DWR UCIP - O. Magana) 11/16/2016 Visible hole through pipe visible on WS end. Sink hole present at the LS ditch. Evidence of pipe repair visible on LS (see photos) however, no permit was found to document the work. Need to contact owner to determine permit authorizing work. Due to the hole in the pipe recommend internal inspection of the pipe through the levee to determine pipe integrity. (O. Magana - DWR UCIP) 05/22/2013 Headwall around pipe at LS toe is failing and should be shored up. Flap gate propped open and should be returned to normal function. (W. Wylie - DWR UCIP)

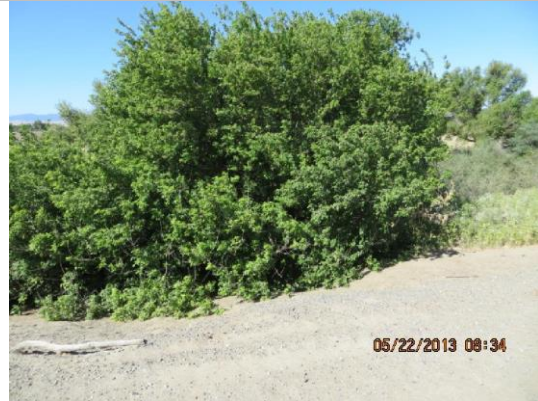
Photo 2 of 3 : UCIP_SP_2018_52565_22440.jpg

Pipes visible under foliage on WS toe.

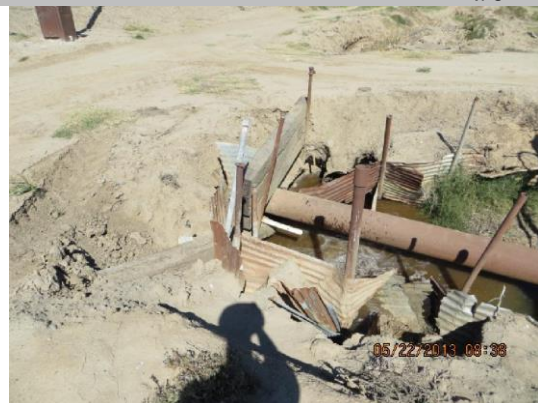
Photo 3 of 3 : UCIP_SP_2018_52565_22439.jpg

Headwall failing at drainage ditch on LS toe.
